Forest Service SAFECOM Summary June & July 2007

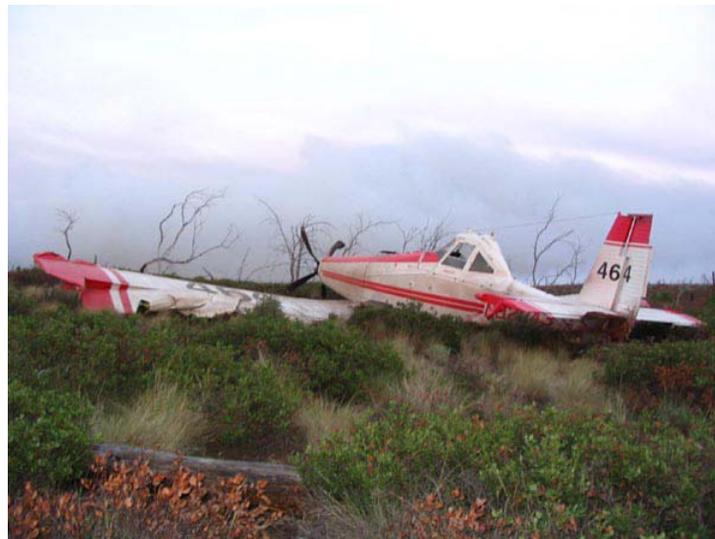
NTSB Identification: **LAX07TA208**
Aircraft: WSK PZL Mielec M-18A, registration: N92043
Injuries: 1 Minor.

On July 7, 2007, about 1916 Pacific daylight time, a Msk Pzl Mielec, M 18A (a.k.a. "Dromader"), N92043, experienced a total loss of engine power while maneuvering about 20 miles northwest of Burns, Oregon. The airplane was substantially damaged during the pilot's forced landing in a rough, vegetation-covered, open field. During the accident flight, the single engine air tanker (SEAT) was under the operational control of the U.S. Department of the Interior (DOI). Visual meteorological conditions prevailed at the time of the public-use fire suppression flight, and a company flight plan had been filed. The airline transport pilot sustained minor injuries. The DOI operated the airplane under a "call-when-needed" contract with New Frontier Aviation, Fort Benton, Montana. The purpose of the flight was for the pilot to disperse 500 gallons of fire retardant chemical on the Egley Complex Fire in the Malheur National Forest, near Burns. The airplane was operated with a restricted category Federal Aviation Administration (FAA) airworthiness certificate under the provisions of 14 CFR Part 91. The flight originated from Burns about 1903.

According to the pilot, the engine stopped operating while he was overflying the intended retardant drop zone at 1,500 feet above ground level. The pilot attempted to restart the engine, but he was not successful. Thereafter, he dumped the retardant load, made a distress radio call, and forced landed. The airplane came to rest in an upright attitude.

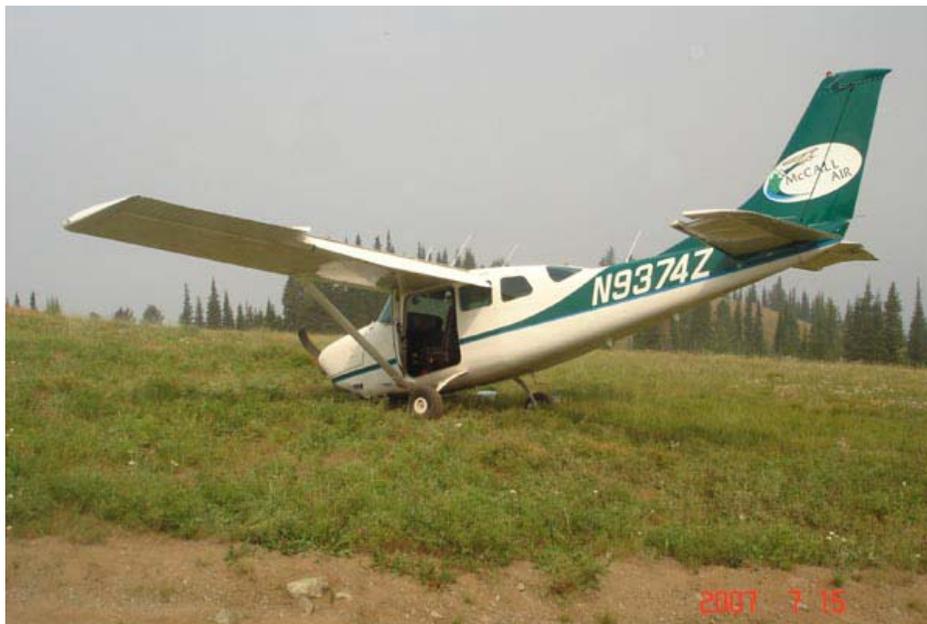
NTSB Identification: **SEA07TA203**
Aircraft: Cessna TU206G, registration: N9374Z
Injuries: 2 Uninjured.

On July 14, 2007, at approximately 0915 mountain daylight time, a Cessna TU206G, N9374Z, was substantially damaged during a forced landing attempt on Horse Mountain, near New Meadows, Idaho. The commercial pilot and his passenger were not injured. The airplane was being operated under contract to the United States Department of Agriculture, Forest Service (USFS) by Wilderness Aircraft II LLC of McCall, Idaho, as a public use flight. The purpose of the flight was to conduct airborne fire reconnaissance. Visual meteorological conditions prevailed. A company flight plan had been filed; the flight had originated from McCall, Idaho, at 0813.

The pilot said that the airplane's engine began losing oil pressure and RPM. He performed a forced landing, but encountered rough/uneven terrain during the landing roll. The aircraft's nose gear collapsed bending the bulkhead keels, nose wheel bracket, and the right wing tip rib.

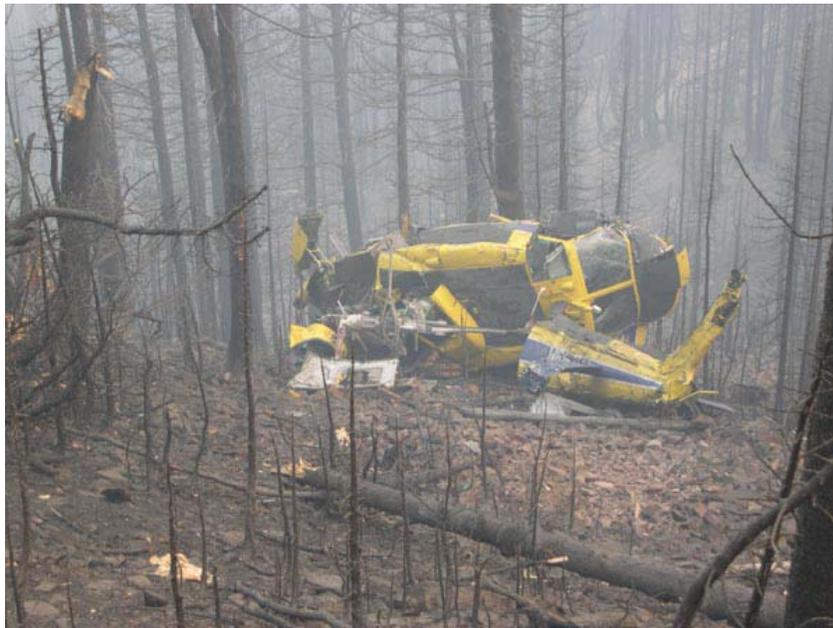
NTSB Identification: **SEA07TA202**
Aircraft: Bell UH-1H, registration: N667HP
Injuries: 1 Minor.

On July 16, 2007, at 0910 mountain daylight time, a Bell UH-1H helicopter, N667HP, sustained substantial damage when it impacted terrain following a loss of control while departing a remote landing zone near Benchmark, Montana. The commercial pilot, the sole occupant, sustained minor injuries. The helicopter was registered to Leading Edge Aviation LLC of Clarkston, Washington, and under the operational control of the United States Forest Service (USFS). Visual meteorological conditions prevailed and a company flight plan was filed for the local public use flight. The purpose of the flight was to carry an external load in support of the Ahorn fire on the Bob Marshal Wilderness Area within the Lewis and Clark National Forest.

According to preliminary information provided by USFS personnel, the visibility in the area of the landing zone was fluctuating between 1/4 to 1 mile from smoke. The pilot flew the helicopter from the Benchmark Helibase to the landing zone, arriving over the landing zone without incident and setting down his load of supplies. The ground crew attached a load of firefighting equipment that was to be returned to the Helibase. As the pilot transitioned to forward flight to depart from the landing zone, the visibility dropped, and the pilot reportedly lost all visual reference. The helicopter settled into trees and impacted the ground, coming to rest on its right side.

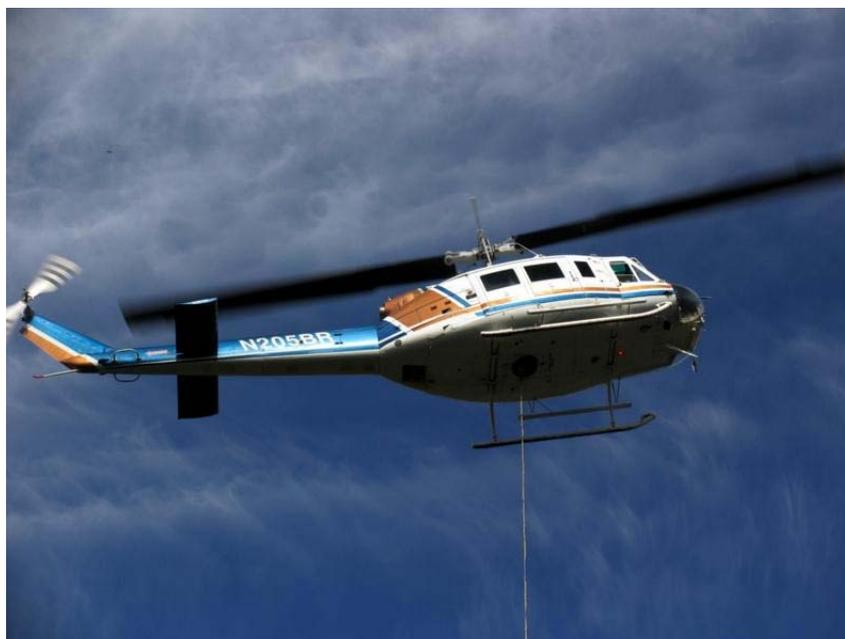
NTSB Identification: **LAX07TA227**
Aircraft: Bell 205 A1++, registration: N205BR
Injuries: 1 Fatal.

On July 23, 2007, about 1100 Pacific daylight time, a Bell 205 A1++, N205BR, impacted trees during a long line mission in support of the Norcross Incident about 1/4 mile southeast of the Happy Camp Airport (36S), Happy Camp, California. The United States Forest Service (USFS) operated the helicopter under the provisions of 14 CFR Part 133 as a long line operation to drop off water blivets for ground crews in the area. The helicopter was destroyed after impacting the heavily forested area, and a post-impact fire consumed the cabin area. The certificated airline transport (ATP) helicopter pilot, the sole occupant, was fatally injured. Visual meteorological conditions prevailed for the local public-use firefighting flight, and a USFS flight plan had been activated.

Several firefighters from the Happy Camp Type II hand crew witnessed the arrival of the helicopter and the subsequent accident sequence. They reported that as the blivets were set down on the forest floor, the helicopter drifted to the right and the main rotor blades contacted a tree. The long line along with the blivets remained attached to the helicopter as it made a turn to the left, stopped momentarily, and then flew downhill. The firefighters reported that there were no abnormal engine sounds emanating from the engine during the event.

According to USFS investigators, the helicopter was outfitted with a 150-foot-long long line; the tree that the helicopter struck was about 165 feet tall. The main rotor struck the top 15 feet of the tree. There were no obvious mechanical malfunctions noted with the engine.

Aircraft was destroyed in post crash fire.

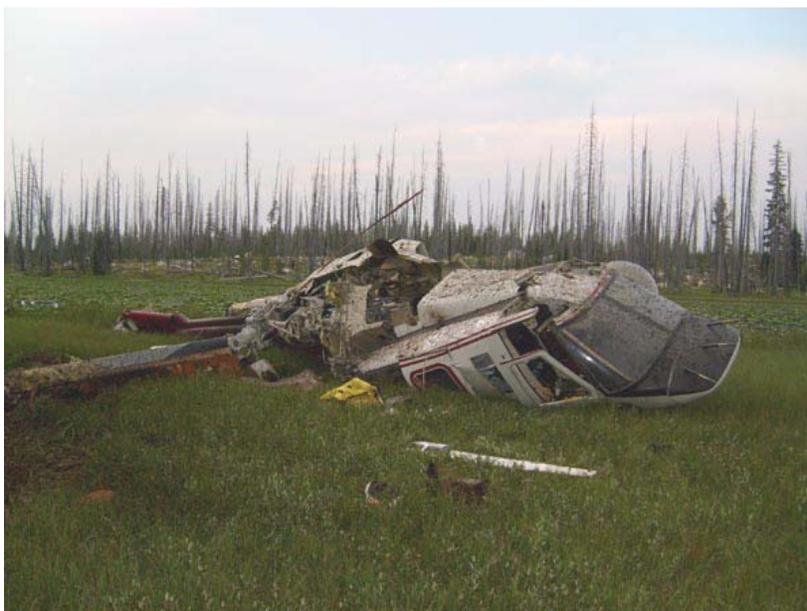
NTSB Identification: **SEA07TA214**

On July 25, 2007, at 1947 mountain daylight time, a Bell 214ST helicopter, N724HT, sustained substantial damage when it impacted terrain following a loss of control while conducting long-line operations in a remote area 22 miles northeast of McCall, Idaho. The airline transport pilot (ATP) sustained serious injuries and the passenger/crew chief, sustained minor injuries. The helicopter was registered to US Leaseco, Inc of Baltimore, Maryland, and under the operational control of the United States Forest Service (USFS). Visual meteorological conditions prevailed and a flight plan was filed for the local public use flight. The purpose of the flight was to conduct external load operations in support of the Loon fire.

According to preliminary information provided by USFS personnel, the pilot was making an approach to a lake in order to fill a 900-gallon Bambi bucket attached to a 150-foot long-line. As the approach continued, and just prior to the bucket entering the water, the pilot reported that "he was encountering the onset of settling with power." The pilot lowered the collective and initiated a 180-degree turn. Concurrently, the bucket entered the water and the 150-foot long-line pulled the helicopter while the pilot was maneuvering. Subsequently, the helicopter collided with terrain in a marshy area adjacent to the shoreline resulting in substantial damage.
